Smoke and Dye Testing Summary

High Level Sewershed

Test ID	Test Type	Date Inspected	Company / Super.	Blower MH	Ground Condition	Notification Made?	Total Length
S1028-017	Smoke	8/8/2008	ADS/TM	S07UU_006MH	Dry	Yes	1,554.51

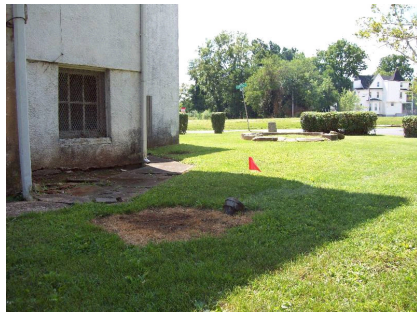
Picture \S1028-017-OB01-P01.jpg

Comments Smoke from cleanout in back yard. 3021 Garrison Blvd.

Comments Back of house, 3021 Garrison Blvd.

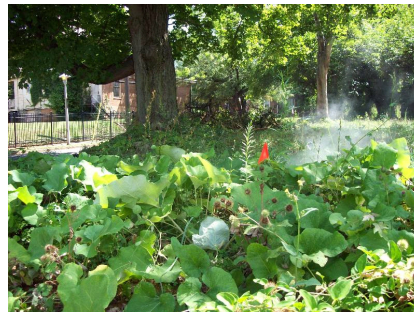
Picture \S1028-017-OB02-P01.jpg

Comments Smoke from cleanout in back yard. 3001 Garrison Blvd.

Comments Back of house, 3001 Garrison Blvd.
